Hardware Improvements to Motherboard and Power Supply

TWOx12 / TWO / 2101 Studio Interface & Extended Hybrid

January 2008, Cleveland Ohio, USA

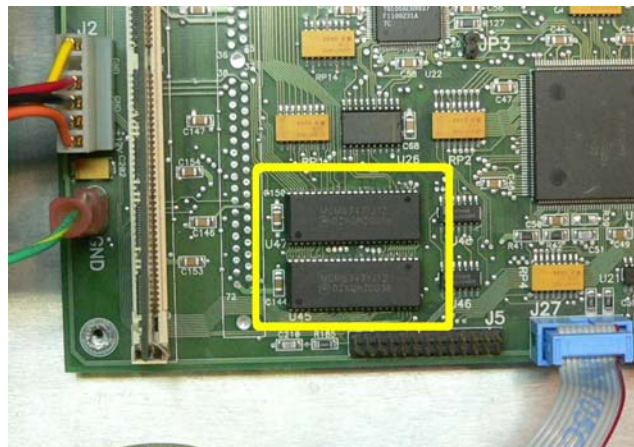
Some units were manufactured incorrectly with the wrong speed SRAM chips. These SRAM chips come in two speeds, 12 ns and 10 ns. The 12ns chips are fine, but the 10ns chips can cause the unit to lock up or be intermittent. Most were caught in production before they were shipped out, however we have recently discovered that a few have made it into the field.

With the lid off and the front of the unit facing you, look for the two identical IC's in the lower left corner of the board, U45 and U47.

The top row of numbers on the IC's will end with either 12 or 10. The ones that end with 12 are the 12ns chips and are OK. However, the ones that end with 10 are the 10ns ones and need to be replaced.

If you find any units with the 10ns markings, contact customer support at the above phone or email to get an RA# and to schedule your unit for a quick repair.

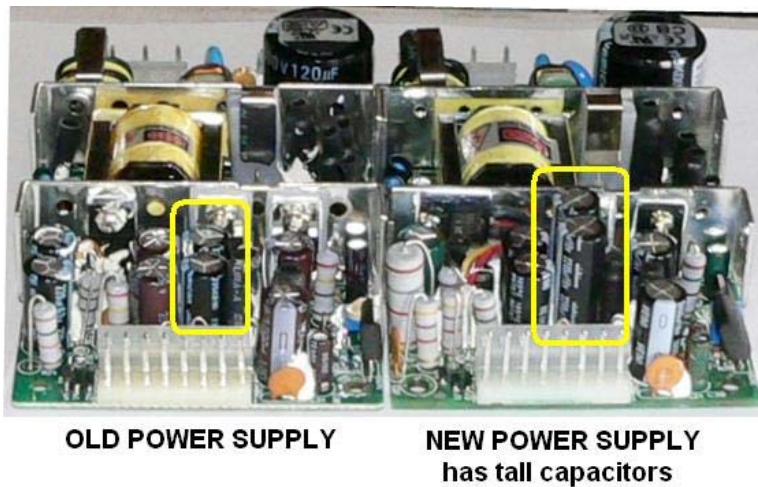
Some units were shipped with power supplies having a manufacturing defect. When a supply fails, a variety of symptoms are possible. Our power supply vender has released a new version of this power supply to correct the issue. All units shipped in the last six months should have the new style power supplies.

A visual inspection of your units' power supply will let you know if you have the current version or not. There are 6 large caps behind the 8-pin Molex connector. The brand on those caps should say "Nichicon". Any other brand caps are unacceptable. Also, on the new supply 2 of these 6 caps are 1cm higher than any other cap on the supply. See the picture below:

If any of your units do not have this new style supply please contact customer support at the above phone or email. We can either ship you a free replacement supply or we can schedule your unit for a quick repair in our shop.
