Telos Zephyr iPort + TZD Software v2.1.3

11 May 2018

UPDATE INSTRUCTIONS:

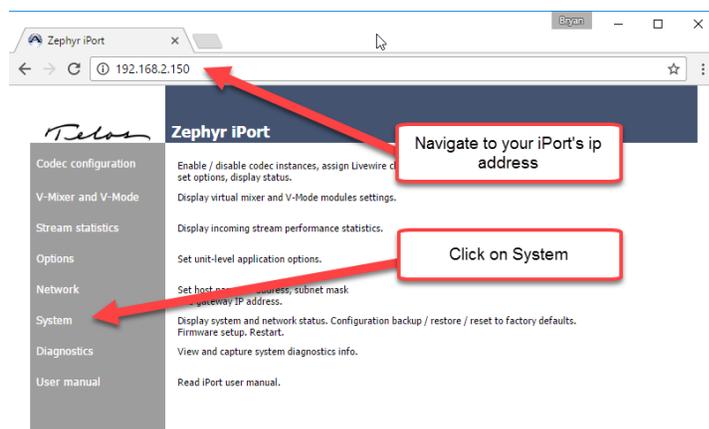
To determine your current version, open a web browser on a computer connected to the same network as your iPort. In the address bar type in the IP address of your iPort. In the example shown here the IP address is 192.168.2.150. If prompted, enter the username and password for your iPort (the default is user with no password)

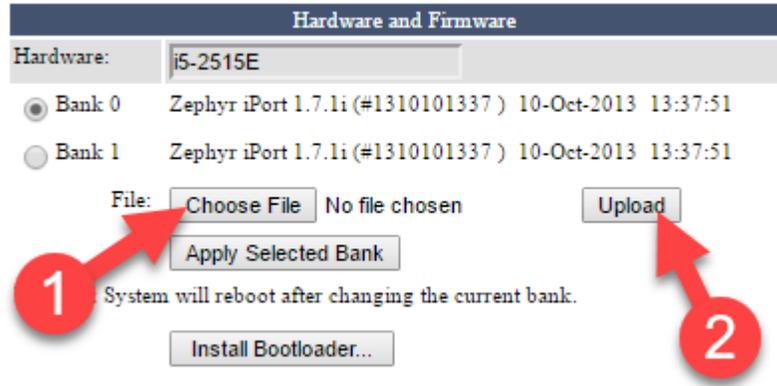
For installing this update, you will install from the System page. From the System page, under “Hardware and Firmware” click on the Choose File button. (If you do not have a Choose File button,

but have a Commit button, you would need to select Bank 1 and click the Commit button. This will free up Bank 1 for updating). Browse to the location where the update file is stored, choose the file and then click Upload as shown below. The system will indicate that it is updating software and after a minute or two will indicate that the update is complete.

A couple of items of note. Your browser may not refresh itself automatically. If it doesn't simply click on one of the other headers in the web page and then back on the System page. Also important to note is that after the Update, the version number shown in the unused bank will not change. If you received the message that the update was successful then everything is complete and your system is now ready to update to version 2.1.3a. You do not need to reboot the iPort at this stage.
